Manhole Inspection Summary

Manhole # S21M__016MH

Location Address: **1938 christian-ramsay alley**

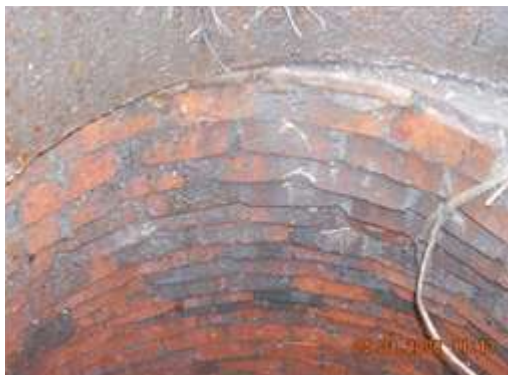
Defect 2

Frame Offset: **2** (in.) Condition: ☐ Sound ☐ Cracked ☒ **Leaks**

inflow evidence;frame leaks

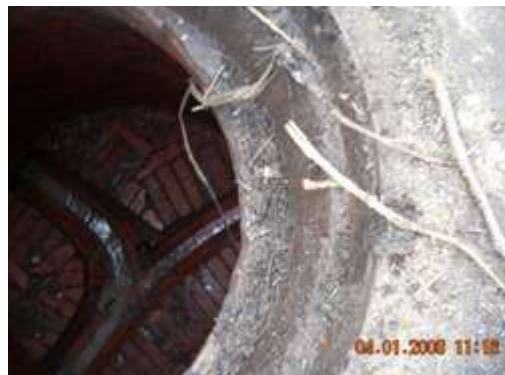
Defect 1

frame offset

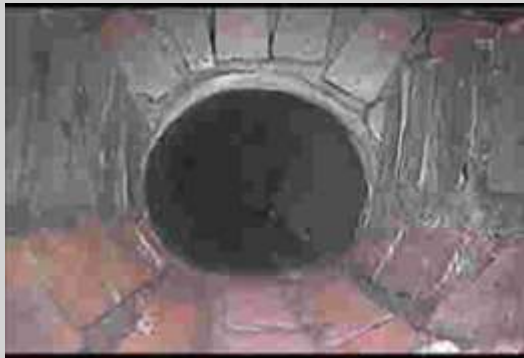
12 O'Clock Outflow

8 in. Circular Gravity Sewer
Pipe Out @ 12 O'Clock

Pipe Height: **7.2** (in.) Rod and Bar (Angled)
Pipe Material: **Clay** ☐ Pipe Lined
Invert Depth: **6.91** (ft.) Flow Characteristics: **Slow**
Deposits: ☒ None ☐ Mud ☐ Sludge ☐ Debris ☐ Grease
Silt Depth: **0** (in.) Deposits Extent:
Infiltration: **None** Pipe Seal Cond: **Sound**

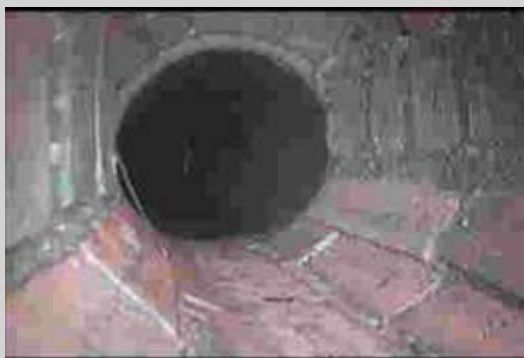
3 O'Clock Inflow

8 in. Circular Gravity Sewer
Pipe In @ 3 O'Clock

Pipe Height: **8.4** (in.) Rod and Bar (Angled)
Pipe Material: **Clay** ☐ Pipe Lined
Invert Depth: **6.79** (ft.) Flow Characteristics: **Slow**
Deposits: ☒ None ☐ Mud ☐ Sludge ☐ Debris ☐ Grease
Silt Depth: **0** (in.) Deposits Extent:
Infiltration: **None** Pipe Seal Cond: **Sound**

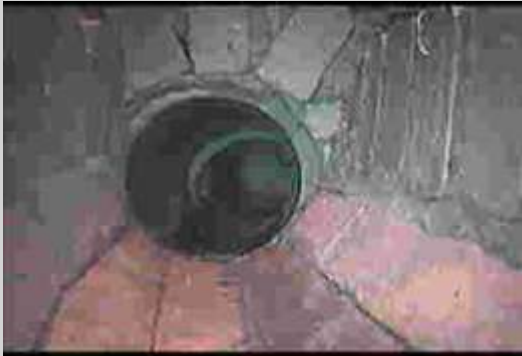
7 O'Clock Inflow

6 in. Circular Gravity Sewer
Pipe In @ 7 O'Clock

Pipe Height: **6** (in.) Rod and Bar (Angled)

Pipe Seal Cond: **Sound**
